Patient:

- Male, 40 years old
- Diagnose: Pacemaker system endocarditis, systemic infection.
- Organic HD: dilated CMP, NYHA 3, EF 25%

Operations: 01/01/2006 CRTD Medtronic Marquis
08/10/2009 replace pacer in the same pocket
(Medtronic Concerto)
implanted new LV lead (reason: no
capture and no sensing of LVL)

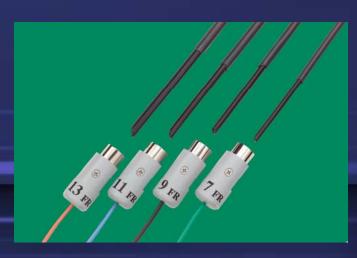
All leads except LV removed using the tools:

Locking stylet

Polyethylene sheath

Electrosurgical dissection sheath

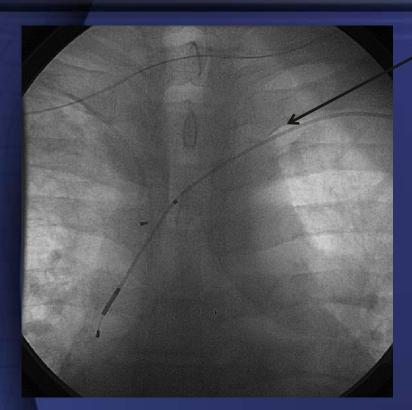
Retained segment with tip and ring markers still in vein

The LV lead was pulled by manual traction, mostly removed but distal segment (looks like 2 cm) with tip and ring retained in innominate vein (x-ray visible)

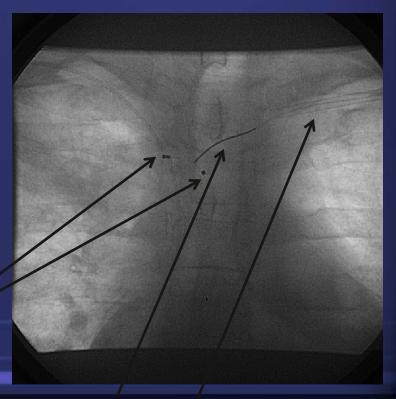
Lasso catheter approaching the retained segment via subclavian sheath

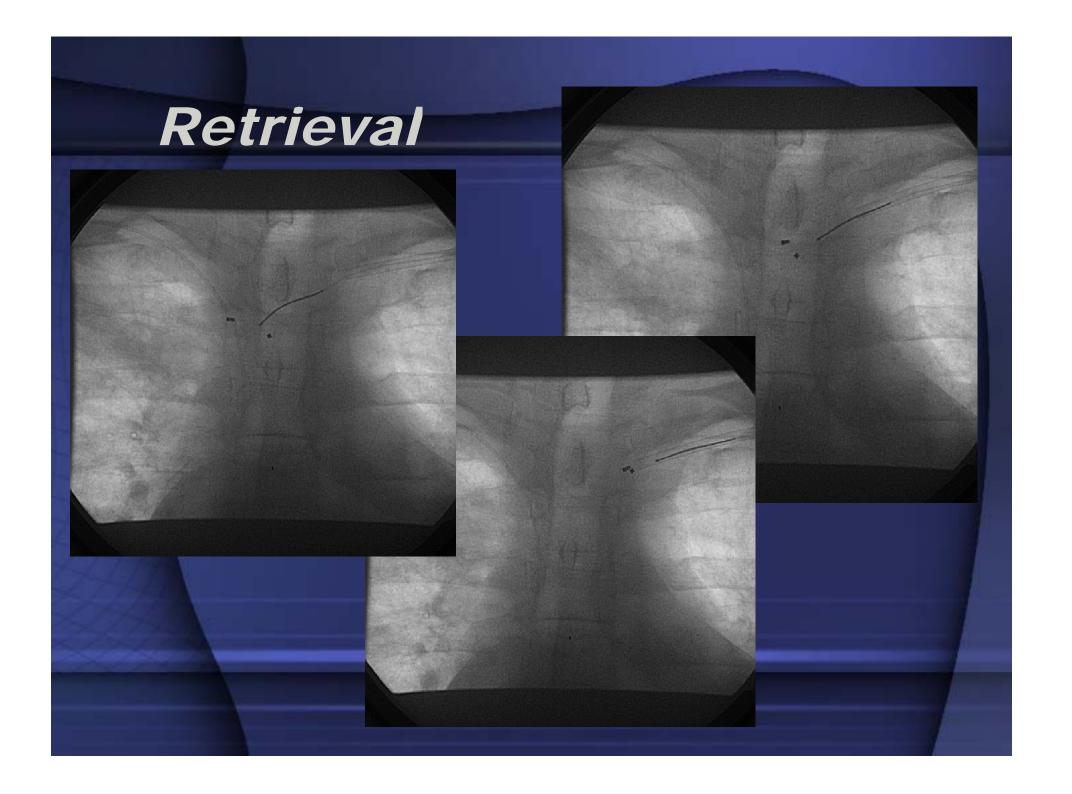
Visible markers

Radiolucent part (10 cm in length!)

When extracting lead segments remember that what you see by X ray may only be the tip of the iceberg ...
