# The Role of Echocardiography for the Diagnosis and Treatment of Prosthetic Valve Emergencies in the ICCU - Alik Sagie MD

**Alik Sagie MD, Echocardiographic Lab  
and Valvular clinic,  
Cardiology Department Rabin Medical  
Center, Israel**

# Prosthetic valve emergencies in the ICU

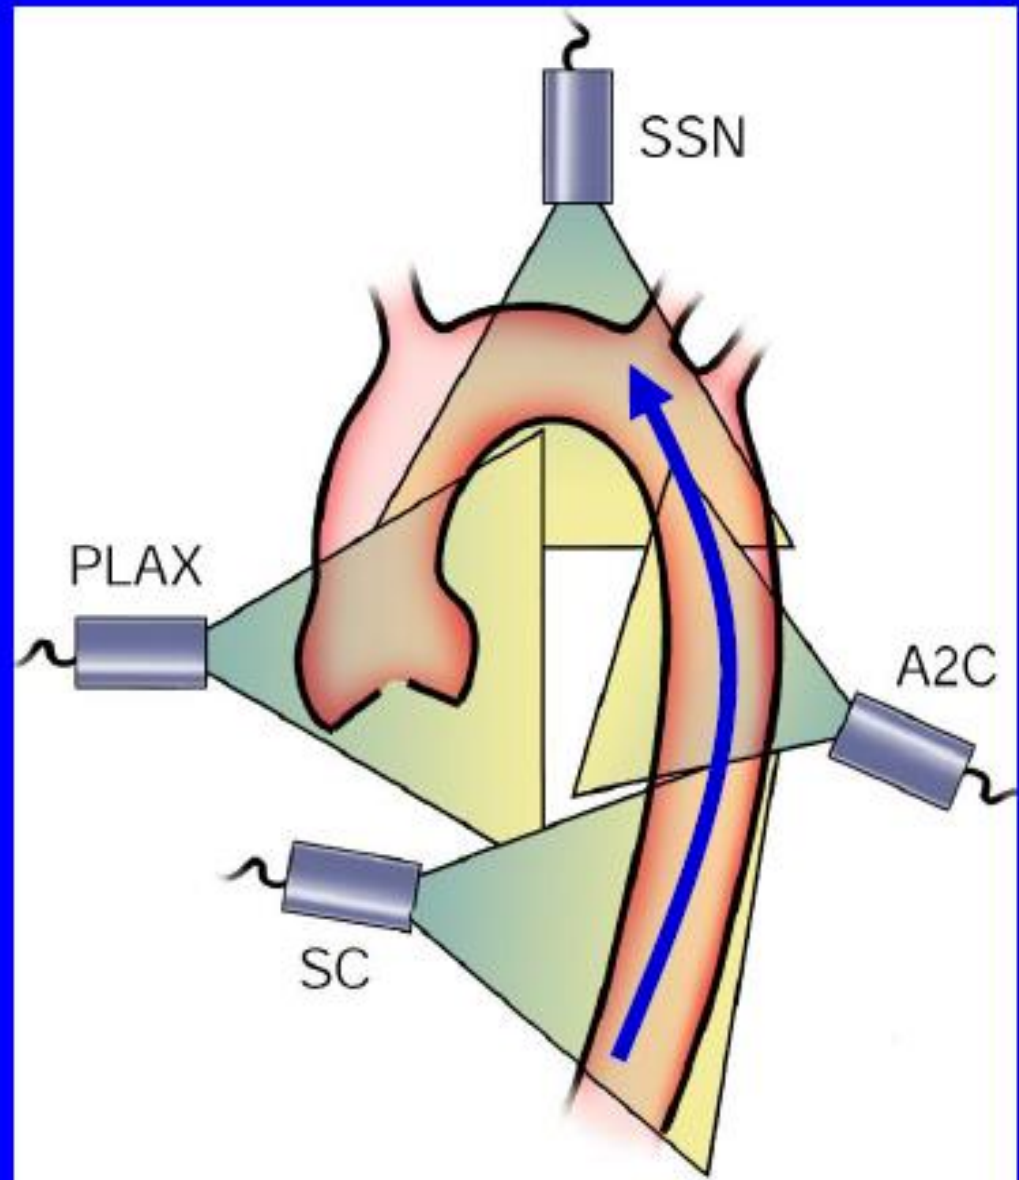
# Holo-diastolic flow reversal in the distal aorta

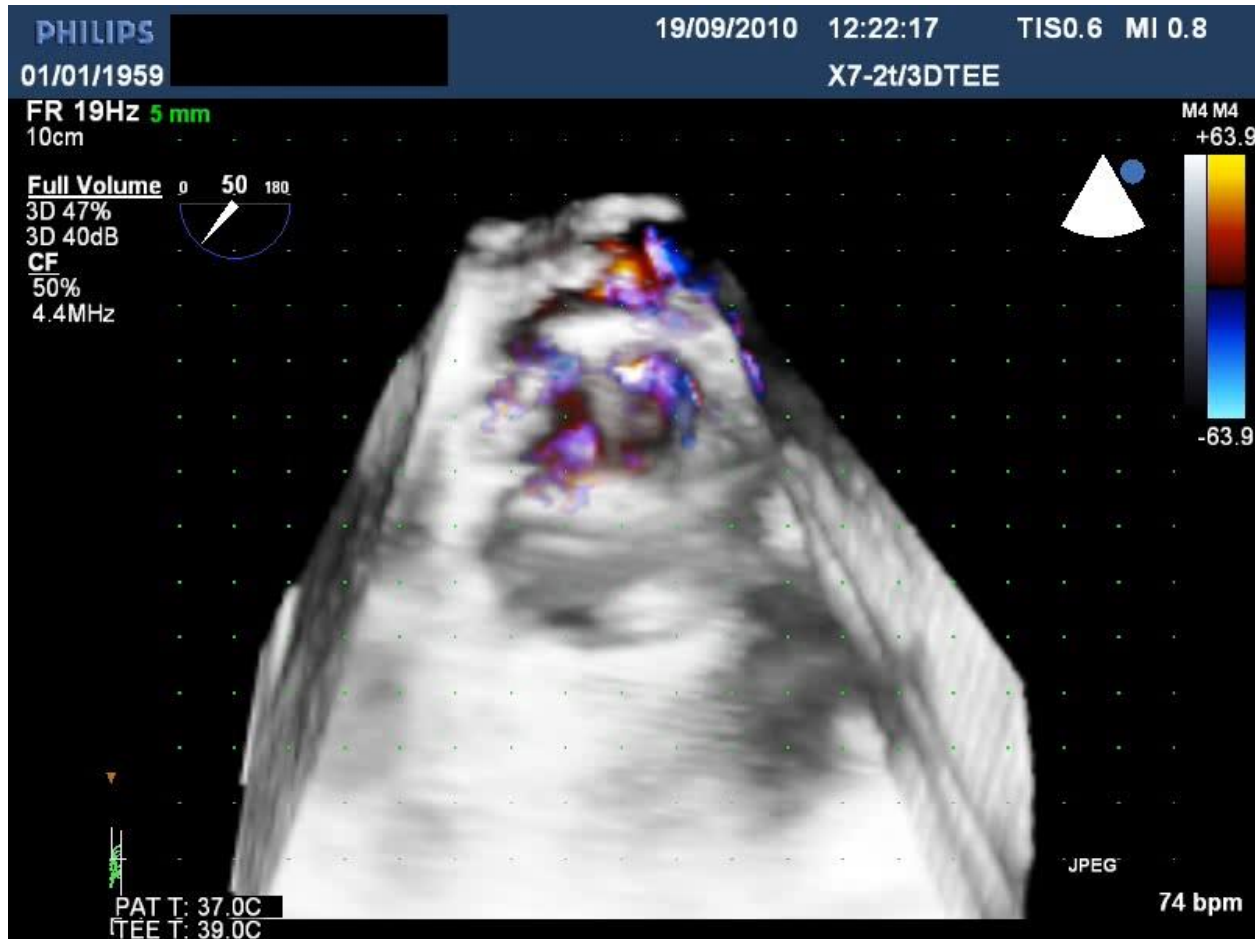
# 3D TEE COLOR FLOW

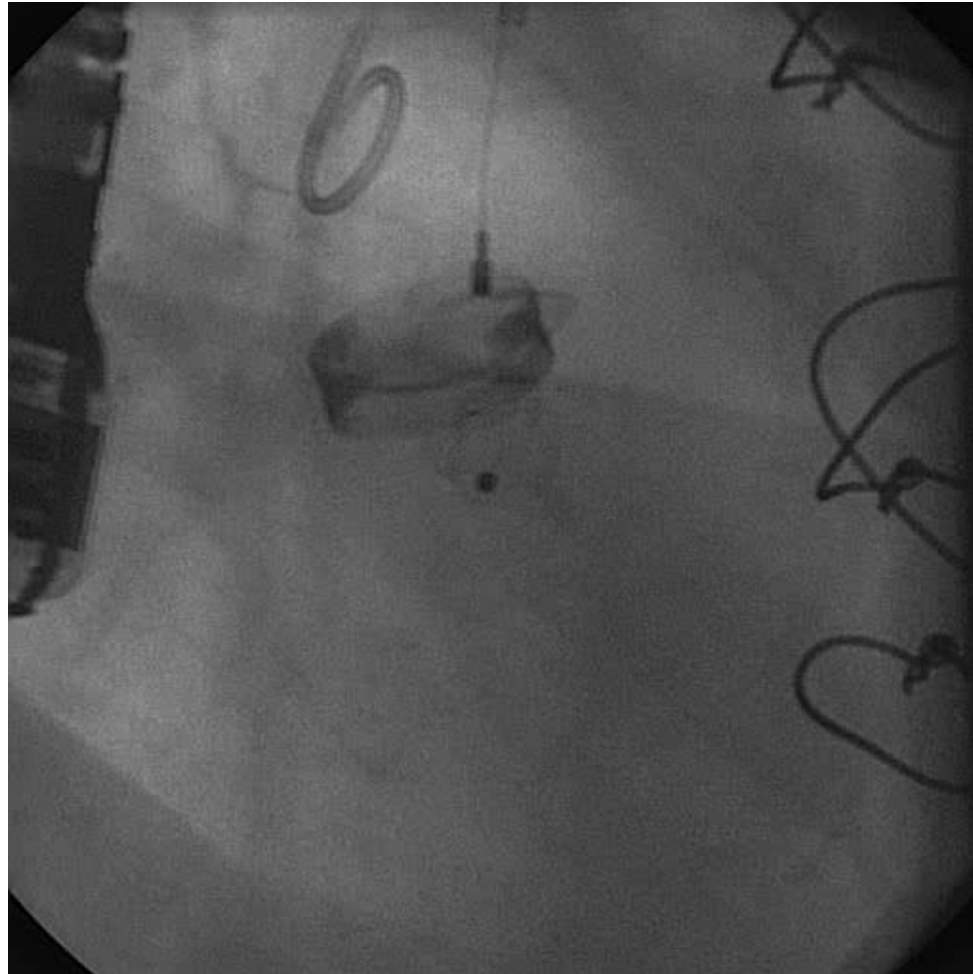
# Percutaneous paravalvular leak closure

## First device in place- residual AR

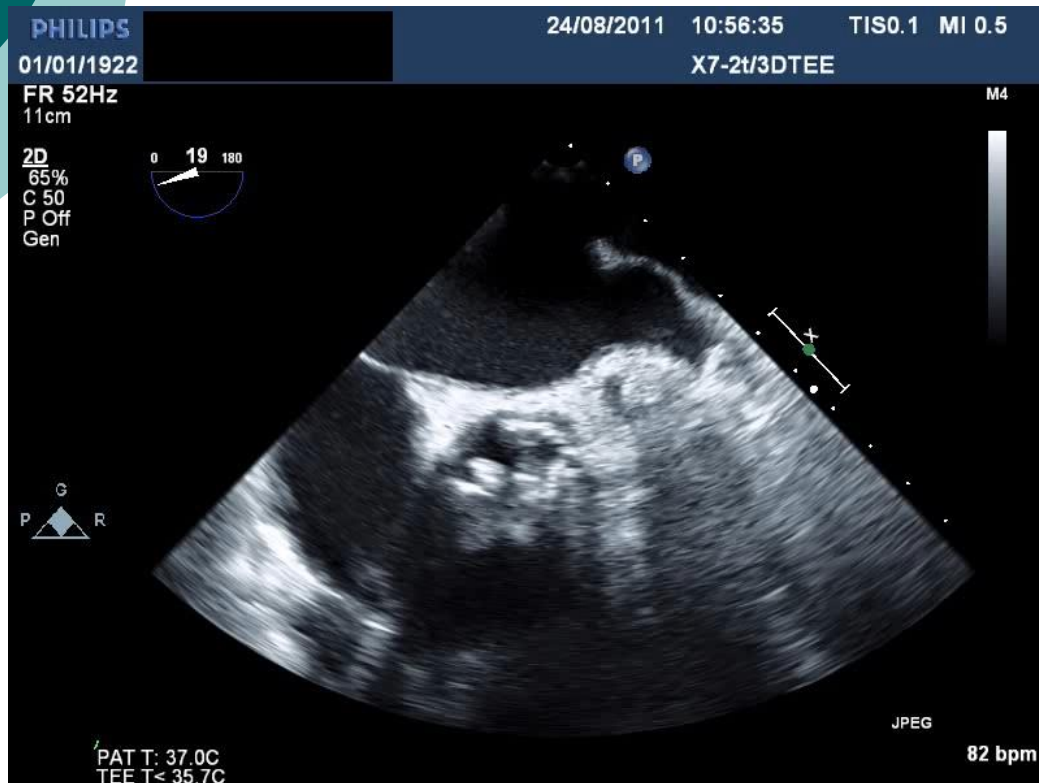
# TEE of degenerated bioprosthesis stenosis

PG = 67 mmHg  
MG = 42 mmHg

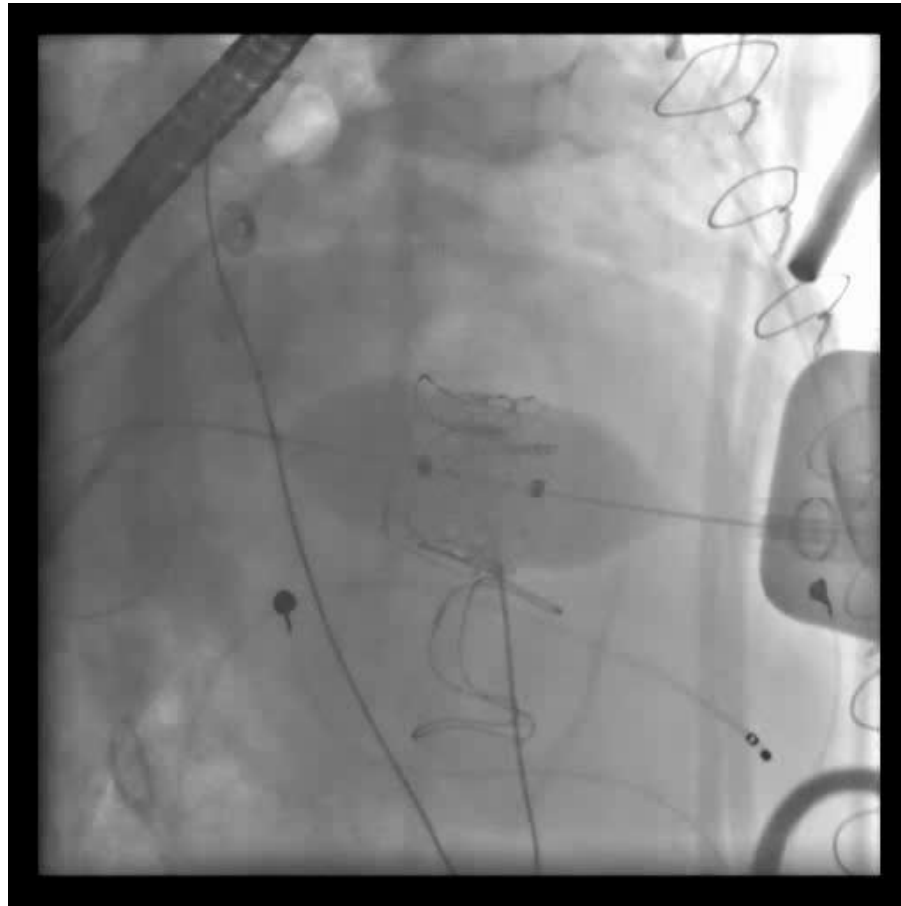
# Balloon expandable valve implantation
