# Paravalvular leaks of prosthetic valves — interventional management

Rafael Hirsch, Adult Congenital Heart Unit Dept. of Cardiology Rabin Medical Center – Beilinson Campus & Tel Aviv University Sackler School of Medicine, Israel

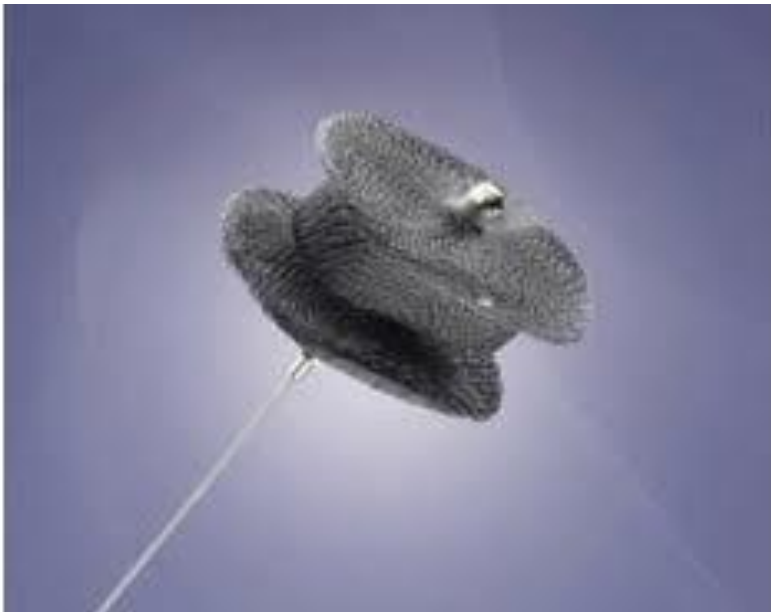
# Catheterization technique

☞ Amplatzer plug III

☞ Different devices: ASD, VSD, PDA, coils

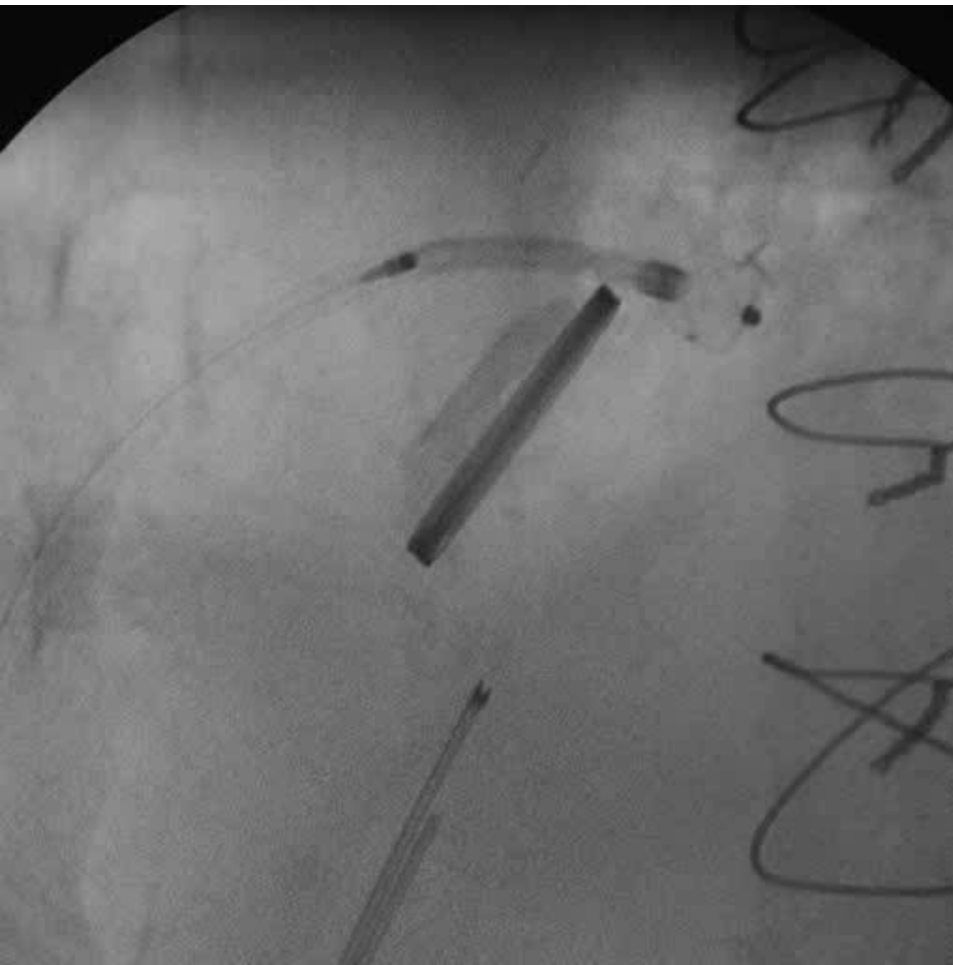
First procedure 3/2010

Implantation of Amplatzer plug III 14/5 mm
