Axillary Vein Puncture

without contrast venography for pacemaker and defibrillator leads implantation.

Dante Antonelli MD, Alexander Feldman MD,
Nahum A. Freedberg MD, Yoav Turgeman MD.

Dept of Cardiology, Ha Emek Medical Center, 18100 Afula

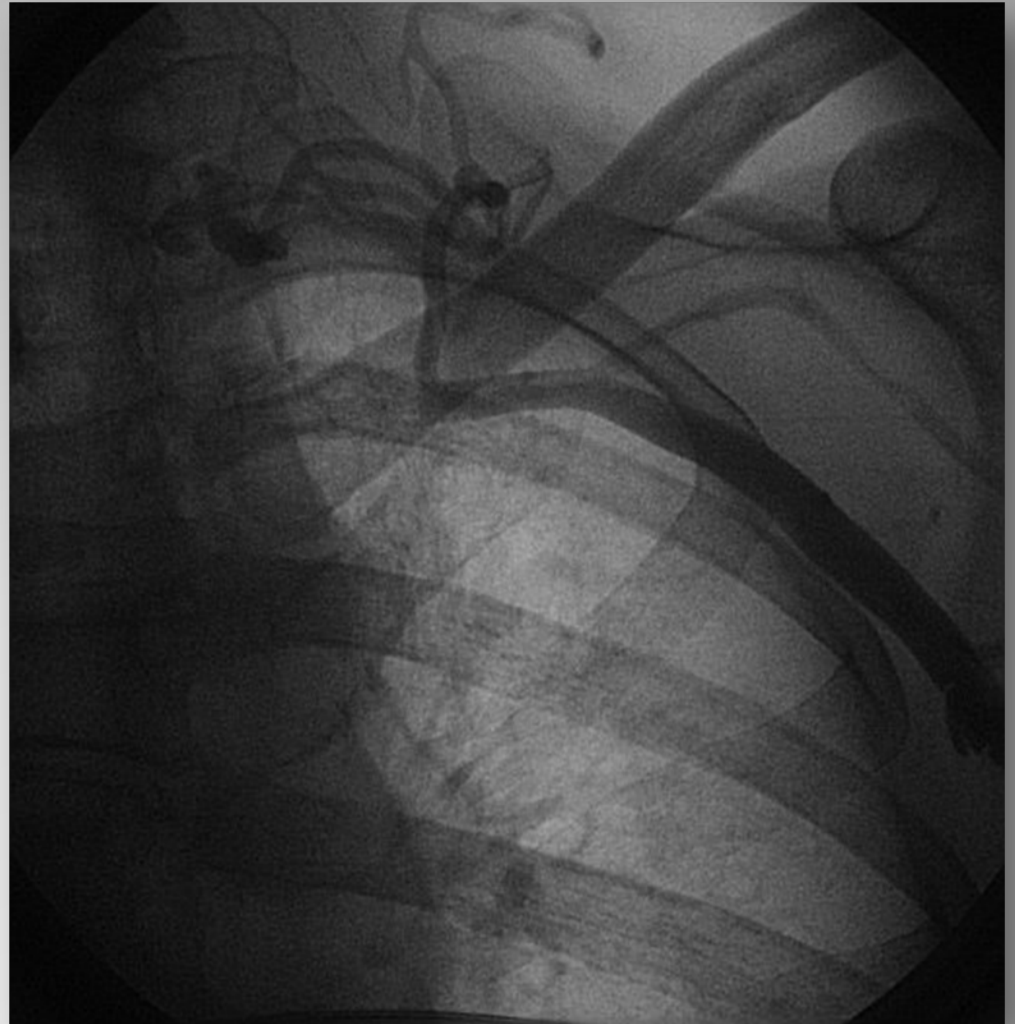
The axillary vein (*v. axillaris*) begins at the lower border of the Teres major, as the continuation of the basilic vein, increases in size as it ascends, and ends at the outer border of the first rib as the subclavian vein.

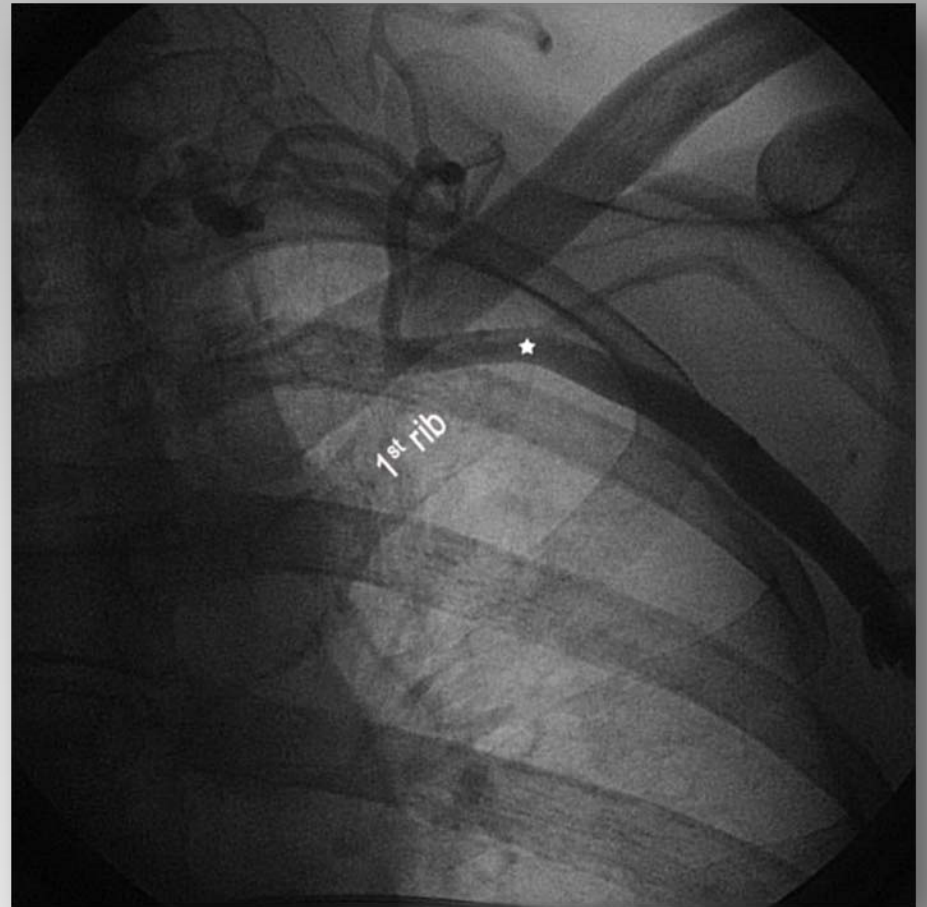
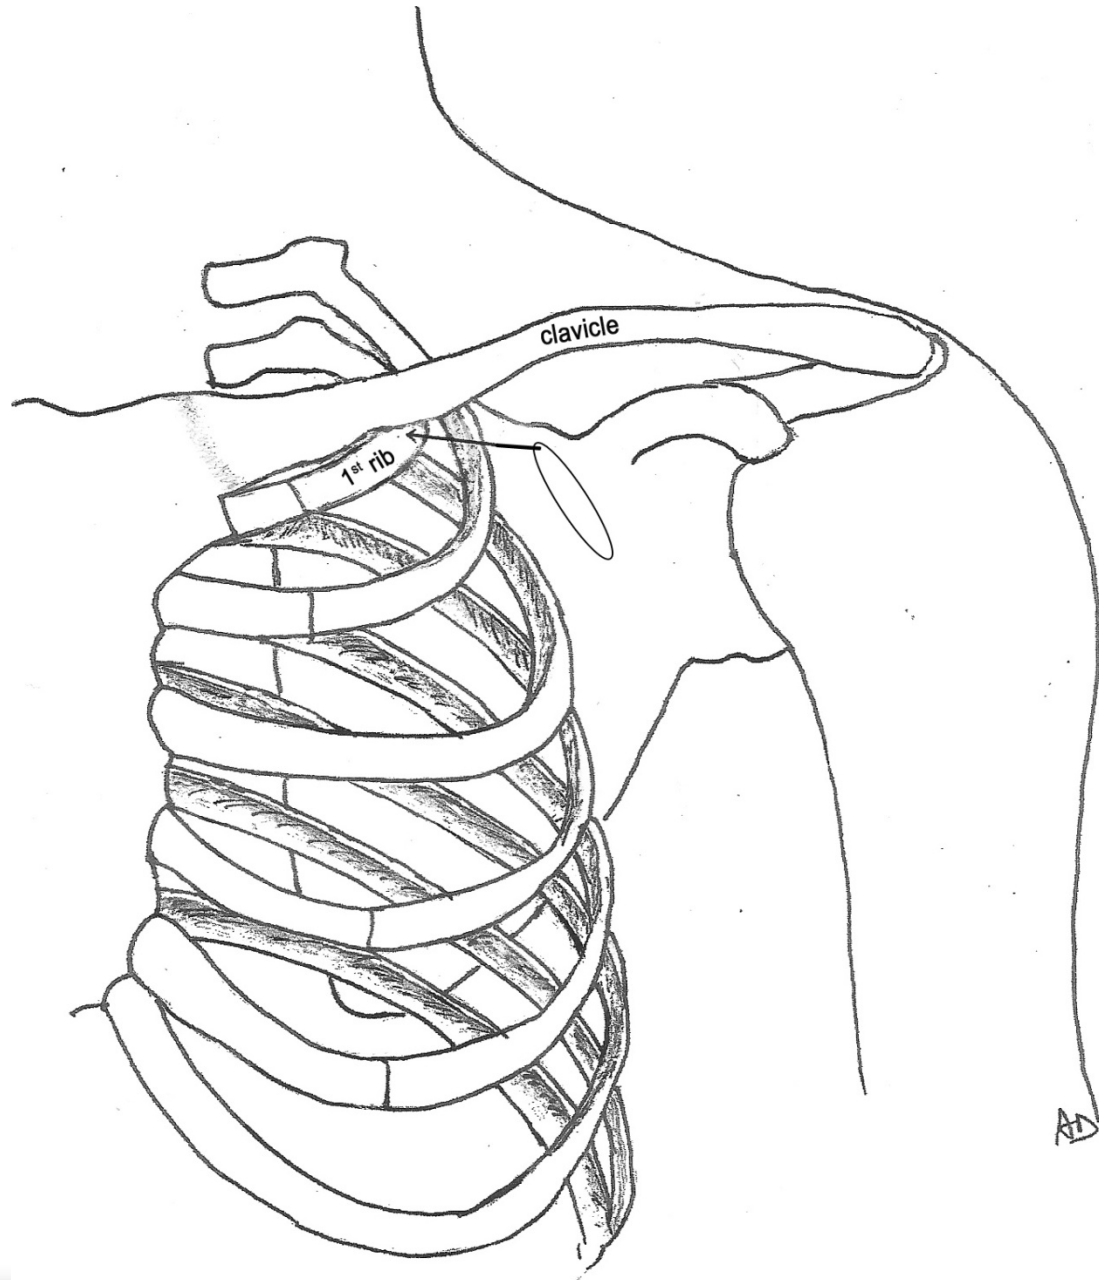
Review of the chest antero-posterior fluoroscopic view of patients placed in supine position showed that, usually, the axillary vein crossed the 1st rib just below the inferior border of the clavicle, at the outer edge of the 1st rib . We used the most lateral edge of the 1st rib below the inferior border of the clavicle as a fluoroscopic landmark.

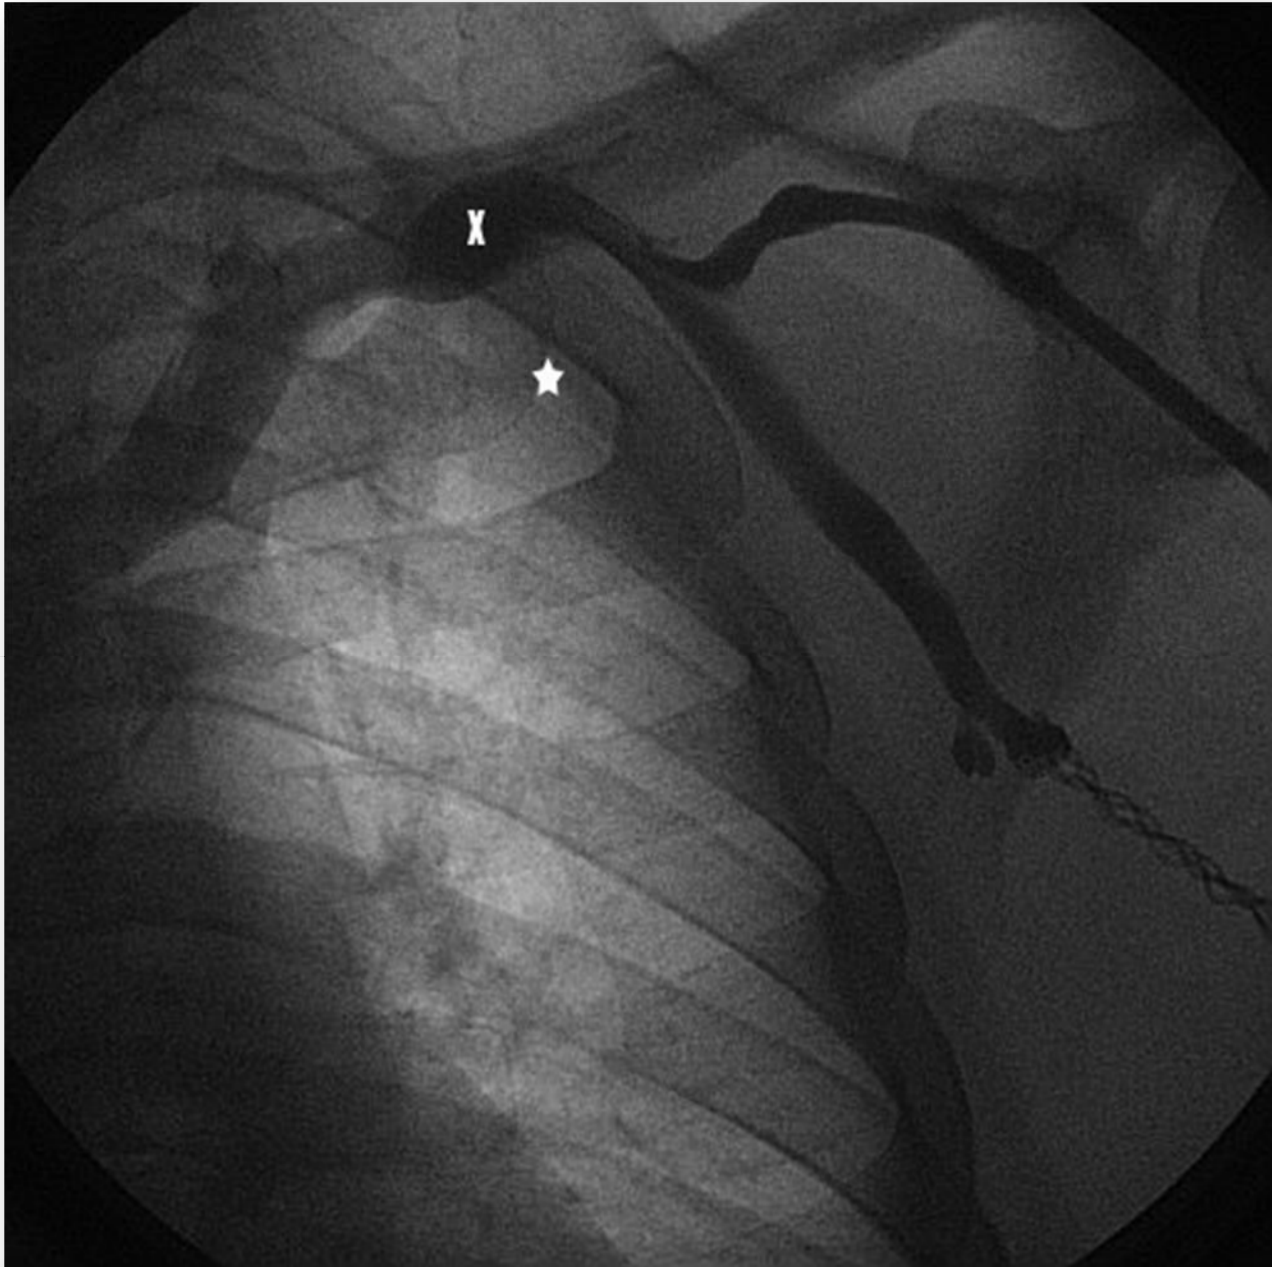
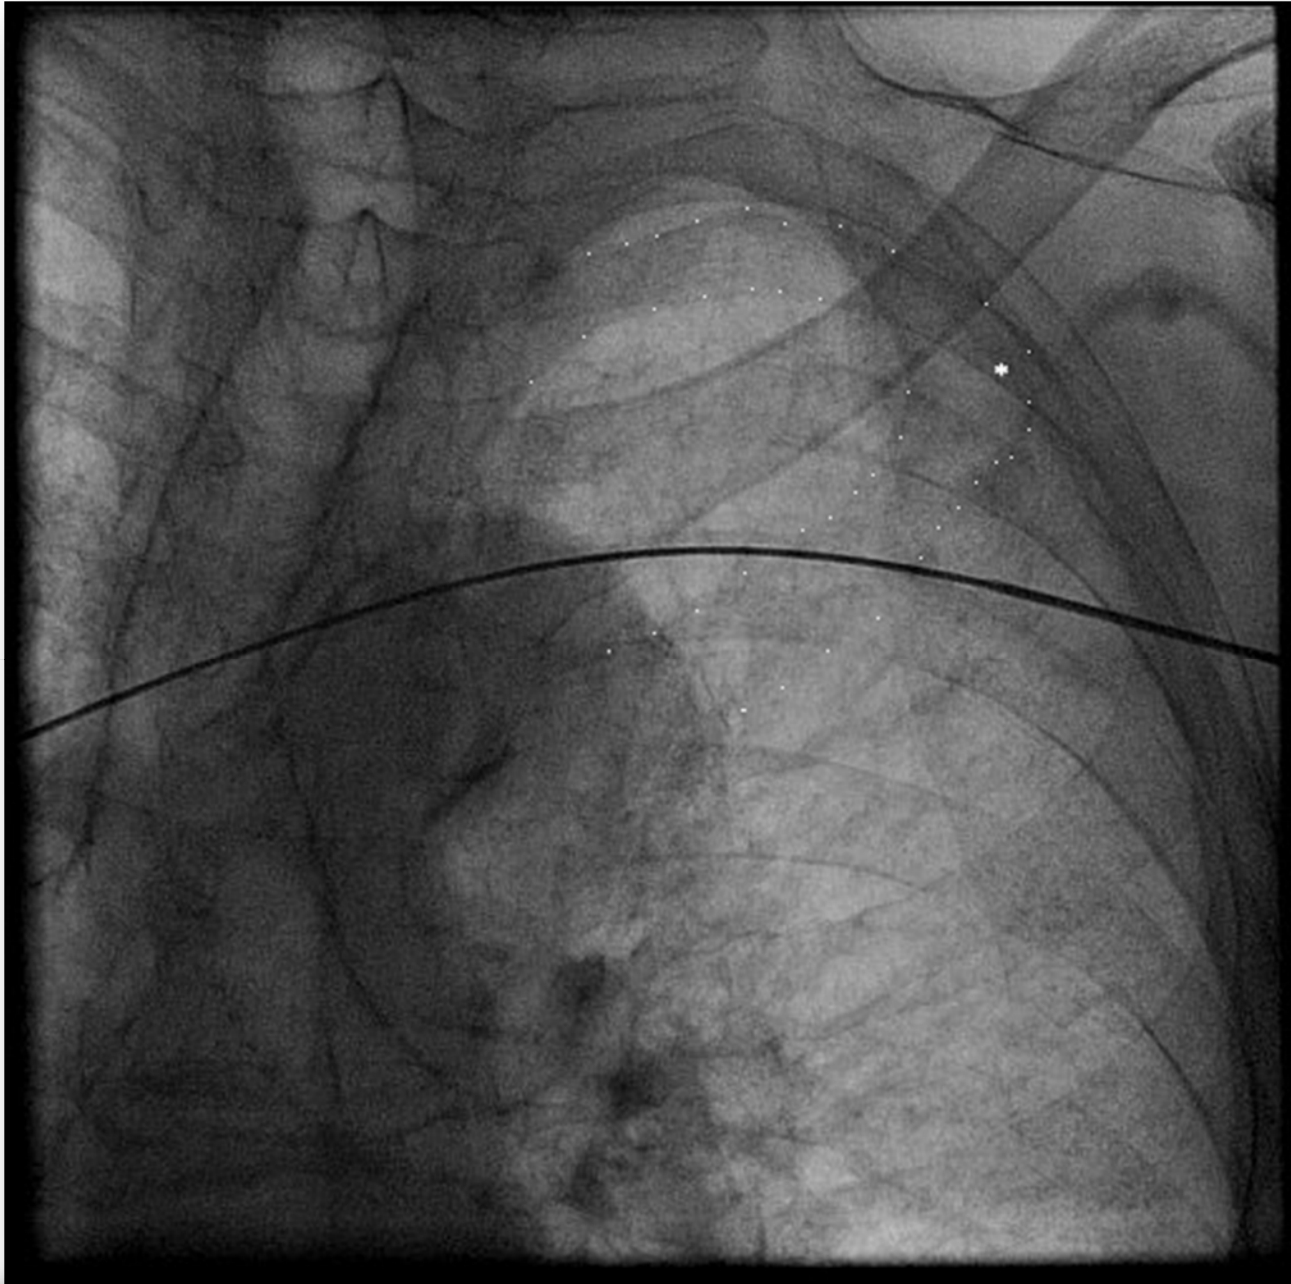
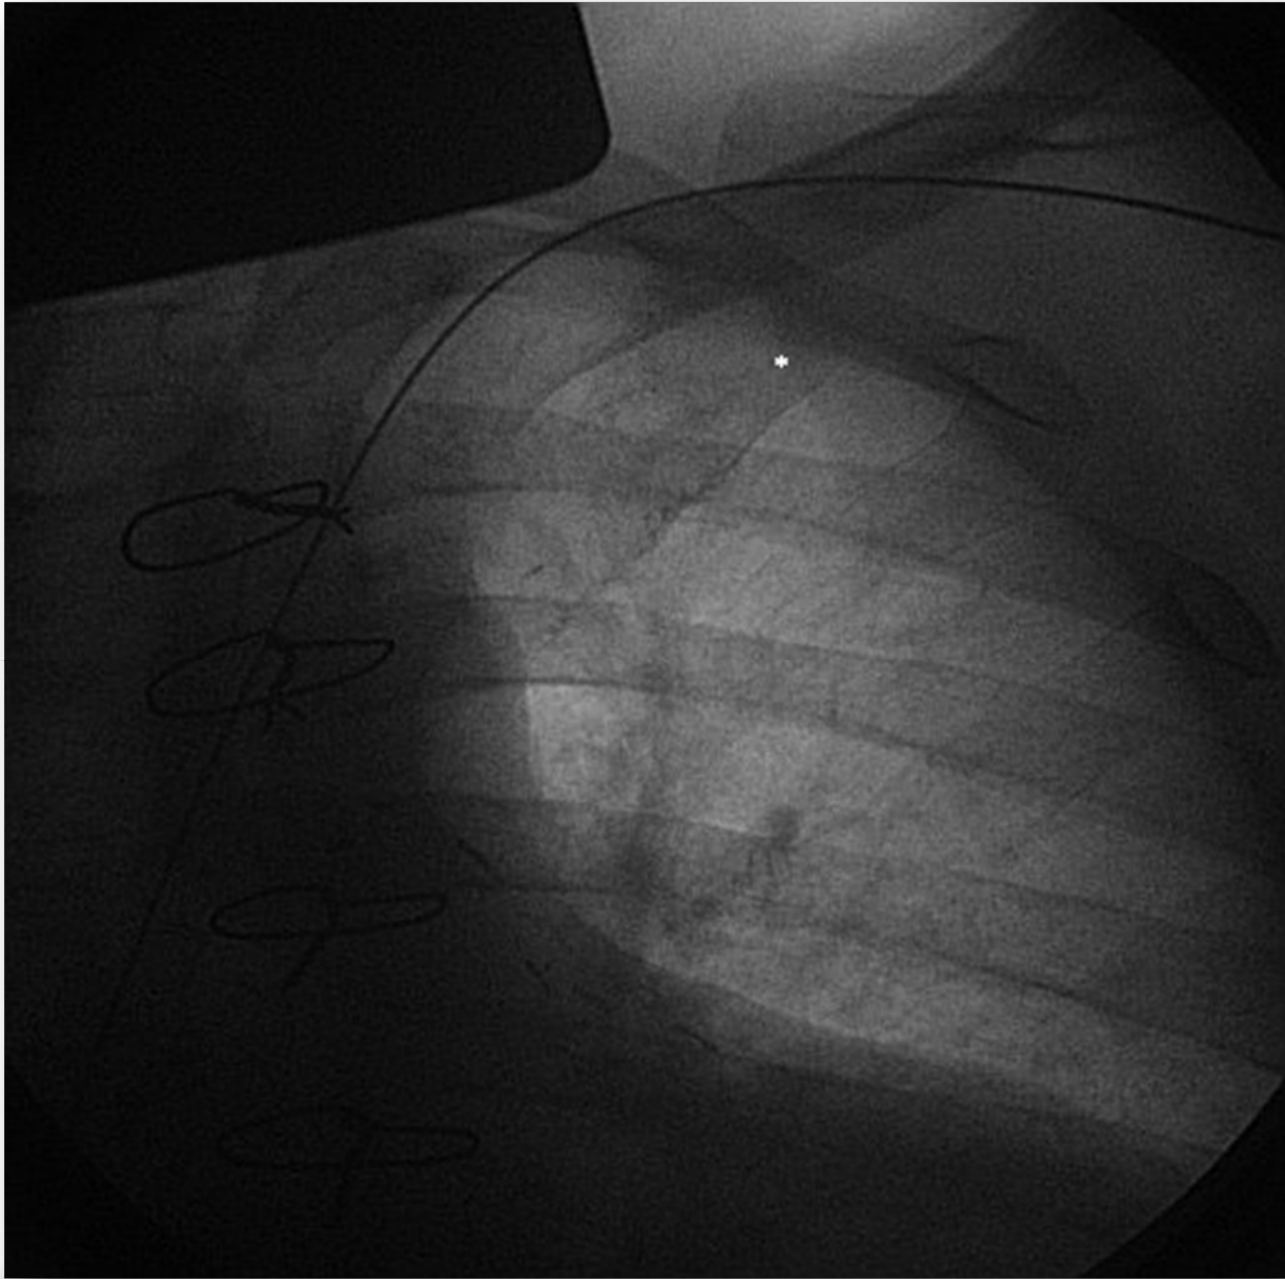
The venography showed that axillary vein did not cross the 1st rib in its most lateral edge below the inferior border of the clavicle in 8 of these patients (80%).
